JACEK CZECHOWICZ

ROZBUDOWA KOŚCIOŁA KARMELITÓW BOSYCH W KRAKOWIE W LATACH 1929 – 1933 WEDŁUG ÓWCZESNEGO DZIENNIKA PRAC BUDOWLANYCH

EXTENSION OF THE CHURCH OF THE DISCALCED CARMELITES IN KRAKOW IN THE YEARS 1929 – 1933 ACCORDING TO ITS CONSTRUCTION LOG FROM THAT PERIOD

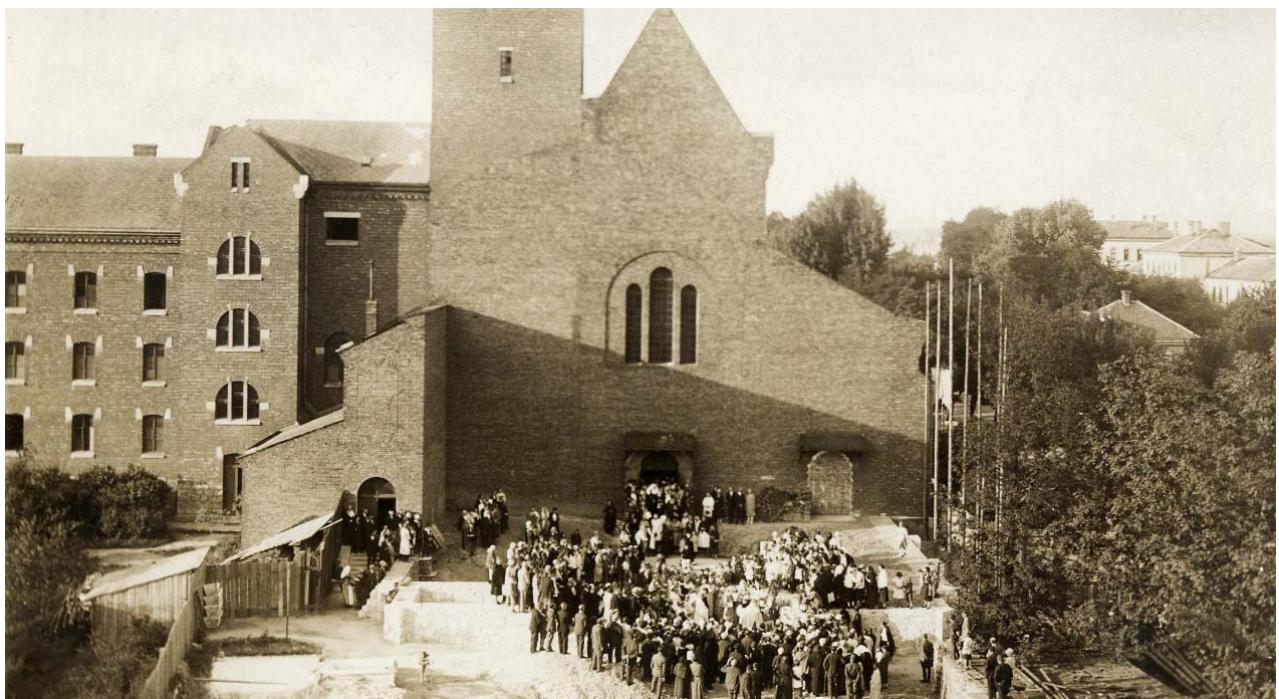
Il. 2. Zdjęcie z uroczystości wmurowania i poświęcenia kamienia węgielnego, 15.08.1929, Archiwum Krakowskiej Prowincji OCD, zdjęcia

Ill. 2. Photograph of the laying and consecration of the cornerstone, 15.08.1929, Archive of the Krakow Province of the OCD, photographs

A photograph documenting the celebration, taken late in the afternoon, probably from the uppermost storey of a townhouse located on the other side of the street, near the corner of Lubomirskiego and Rakowicka streets, depicts the construction site being surrounded by a wooden fence. There is a clear outline of the base walls of the nave section. Inside the level of the terrain appears to be slightly raised—from the south. From the west there are visible foundations prepared for the pillars of the aisle, touching the eastern wall of the gatehouse. The construction site was arranged in a model manner—on the left side we can see neatly stacked boards and nearby—baskets for the moving of construction materials, while to the right there are bricks laid out in cuboid blocks, with timber shores beside them. Along the eastern wall we can see a row of tall, vertical columns for the scaffolding, at a distance of 1,8 m from the wall and spaced around 3 metres away from each other. The entrance to the chapel of Holy Mary of the Sharp Gate appears to be walled off, while the entrance at the axis of the presbytery was still in use (ill. 2).

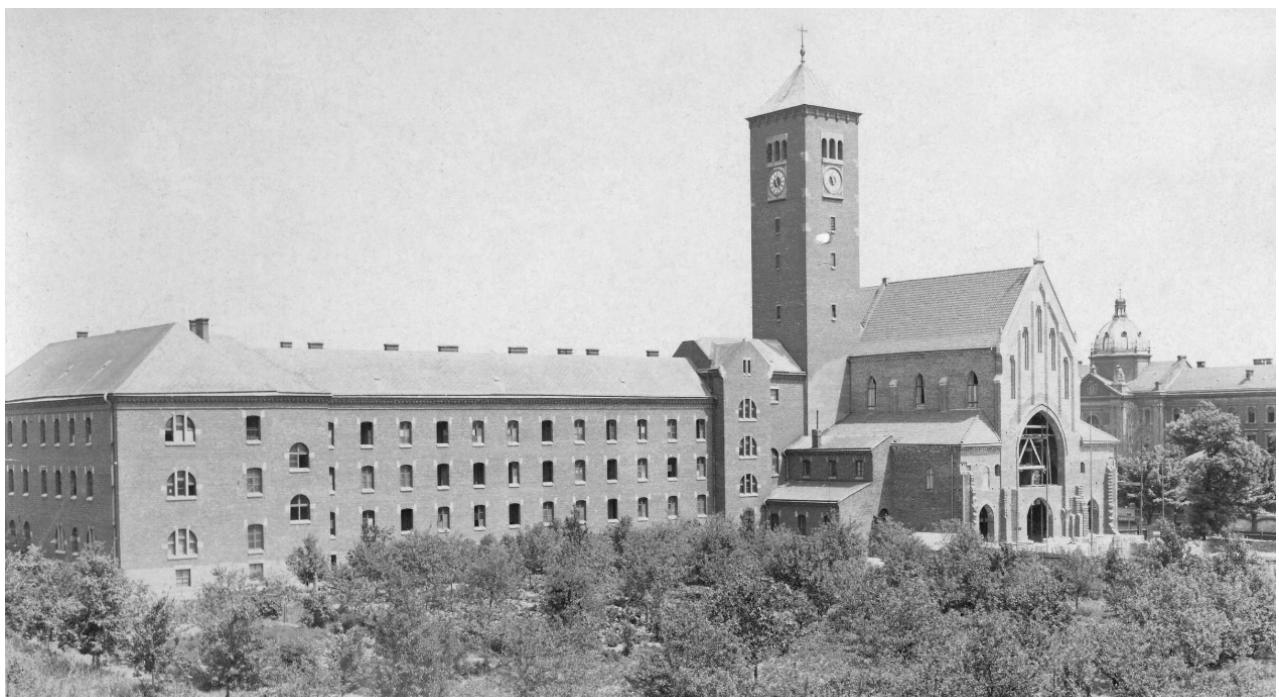
Il. 3. Zdjęcie od strony pd.-zach. wykonane w trakcie prac budowlanych, listopad 1929, Archiwum Krakowskiej Prowincji OCD, zdjęcia

Ill. 3. Photograph from the south-west, taken during construction work, November 1929, Archive of the Krakow Province of the OCD, photographs

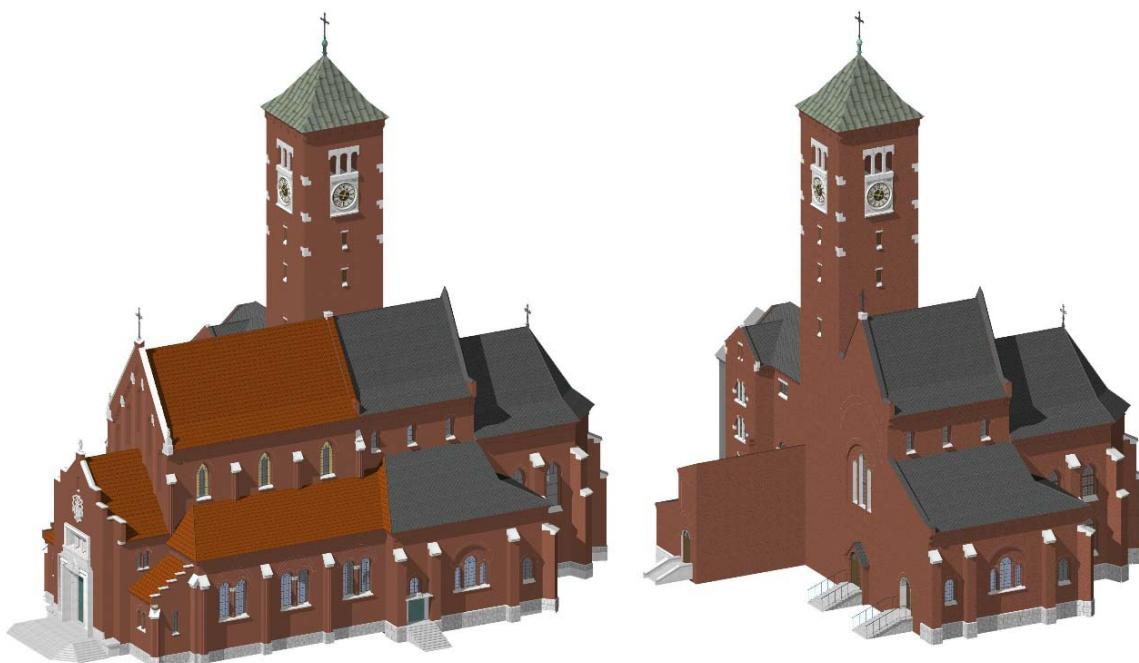
Il. 4. Kraków, kościół Niepokalanego Poczęcia NMP. Z prawej: faza I, 1908-1910, z lewej: faza II, 1929-1933, rys. autor

Ill. 4. Krakow, Church of the Immaculate Conception of Virgin Mary. To the right: phase I, 1908-1910, to the left: phase II, 1929-1933, drawn by author
